## **U.S. 101 MP 111.34 Unnamed Tributary to Stevens Creek (WDFW ID: 990731) Preliminary Hydraulic Design Report**

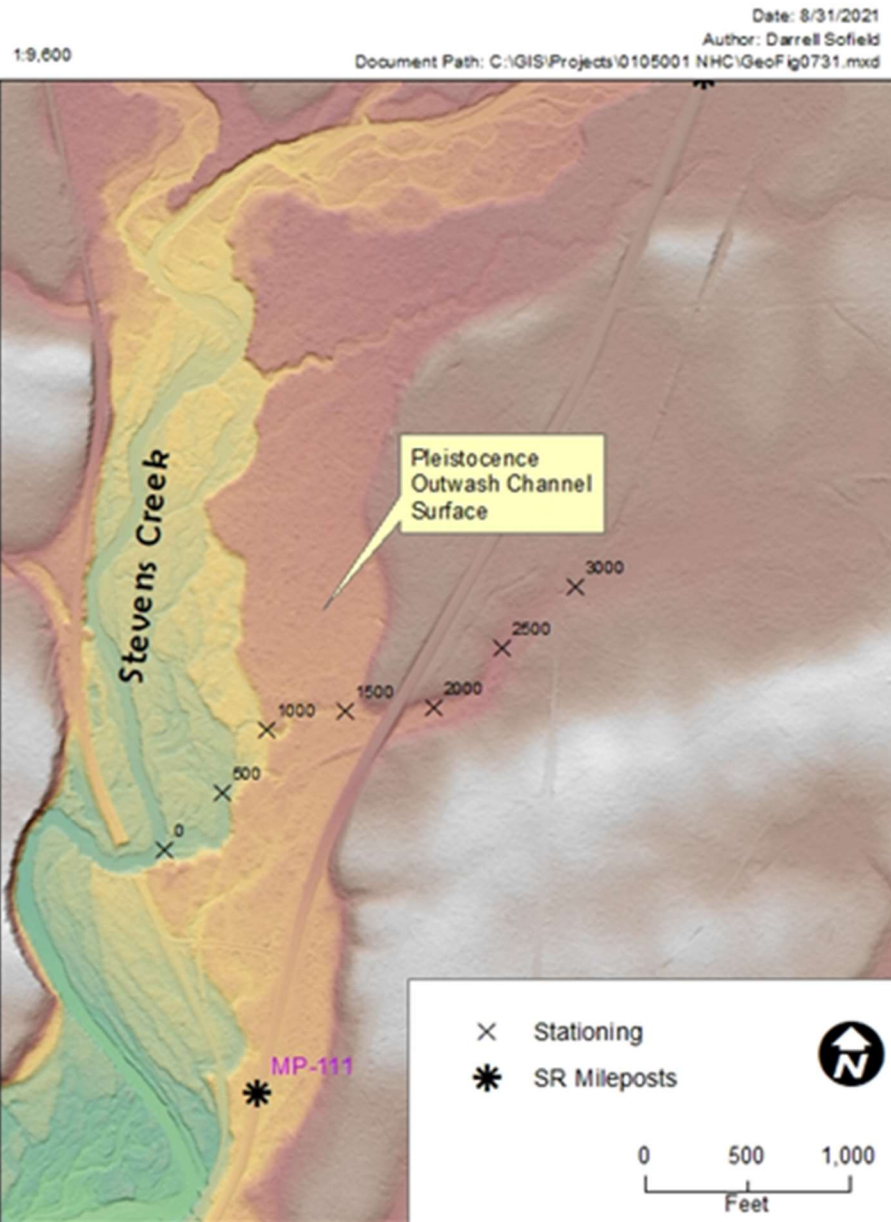
**Figure 4: Lidar-based topographic figure of the project site shows Stevens Creek, stationing for the project stream, Pleistocene outwash channels, and uplands**

The glacial history of basin controls the profile of the project stream, which drains what is interpreted to be a pre-Wisconsin glacial outwash plain (238-270 ft) before downcutting an arroyo into the eastern bank (40 ft of relief) of an erosional channel that extends upstream of the US 101 crossing. Below the crossing, the creek flows across the terraced Pleistocene outwash channels (low gradient and weathered); after crossing these outwash terraces, the creek descends steeply to join the modern alluvial floodplain of Stevens Creek. A hardpan was observed in the channel. The hardpan's consistency ranged from clayey silt to silty sand, to stiff gravelly silt. A Geotechnical Boring (WSDOT 2020) logged sandy silt with gravel below the channel. It has the same color and texture of the hardpan exposed in the channel. A relatively stiff, unweathered, silty sand with gravel was observed at depth 210-190 ft elevation, where the boring was completed.

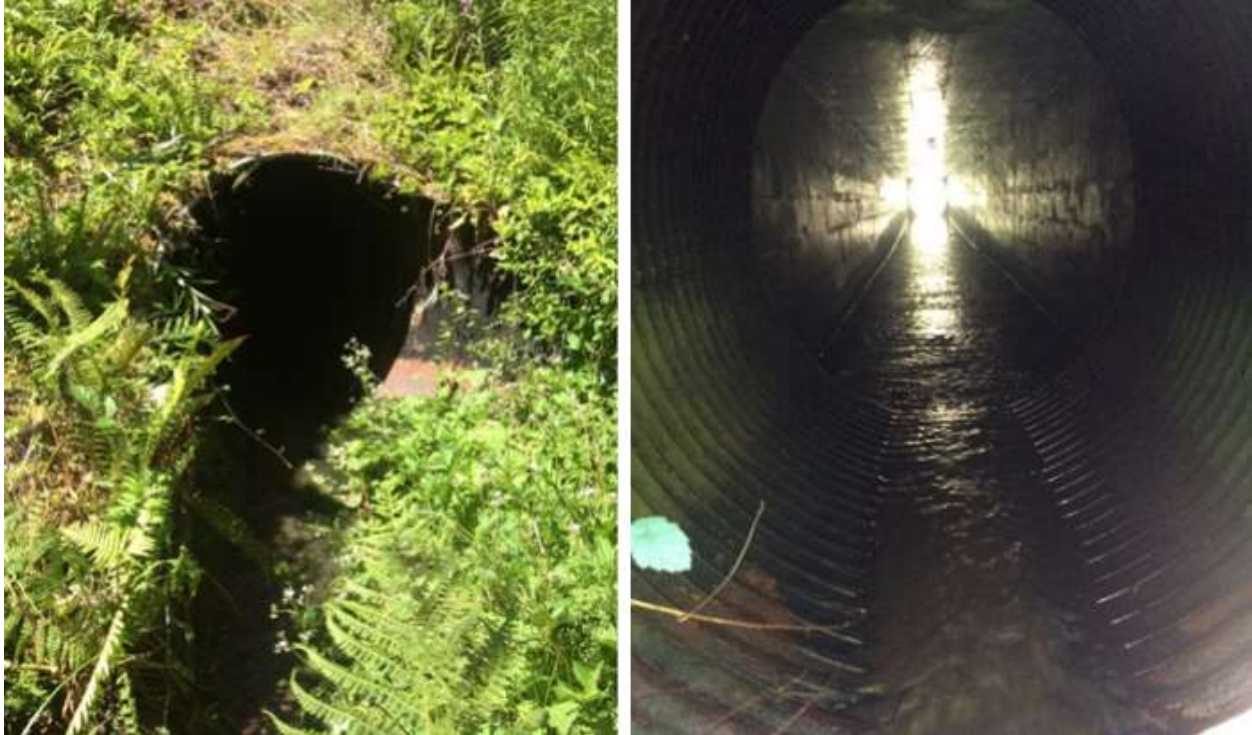
**Figure 5: Culvert inlet (left) and inside of culvert (right)**

The existing structure is a 87-foot-long, 48-inch-diameter circular corrugated metal pipe (CMP) culvert. The culvert has a gradient of 1.2 percent with the inlet invert elevation at 222.4 feet and the outlet invert elevation at 221.3 feet. Road fill depth is approximately 20 feet above the existing culvert based on WSDOT survey data. The inlet has 45-degree wingwalls mitered to the embankment and is round, but transitions to a concrete box culvert in the section under the roadway (Figure 5). The box transitions back to a round outlet that discharges onto a concrete apron (WDFW 2021). The outlet of the culvert is perched about 1 foot above the channel, and the headwalls are mitered to the slope of the road embankment (Figure 6). There is a scour pool below the apron and substrate in the pool is composed primarily of fines.

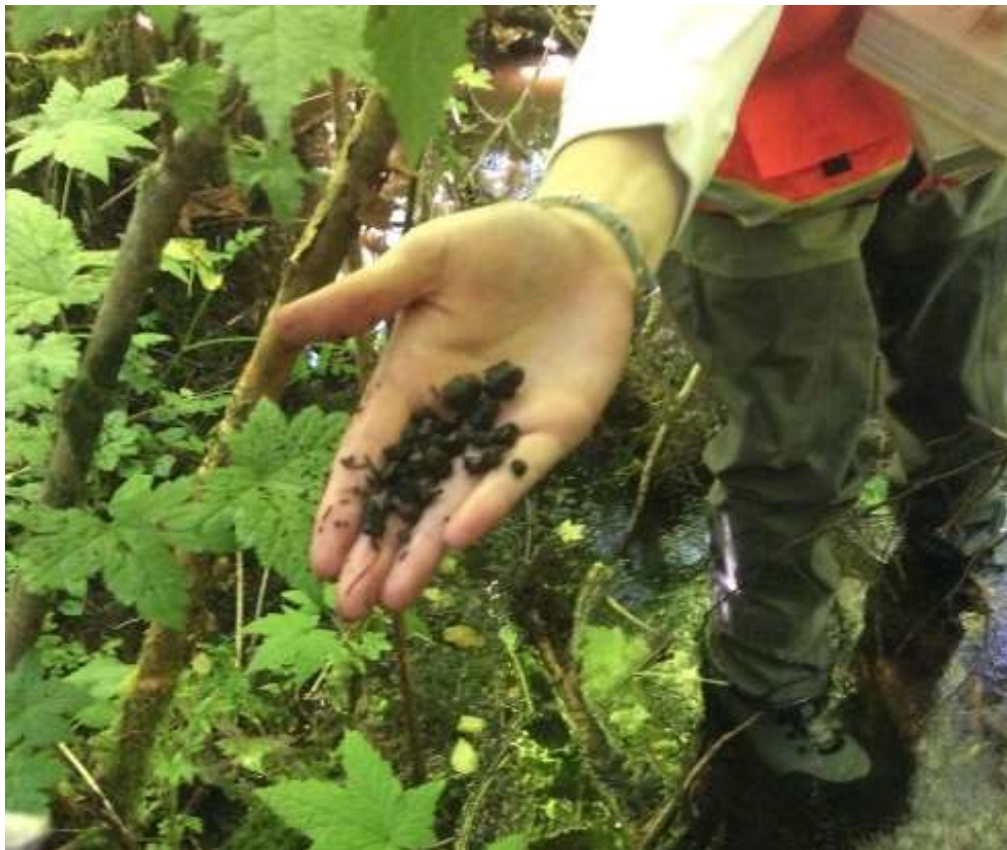
**Figure 9: Small gravels found upstream of culvert**

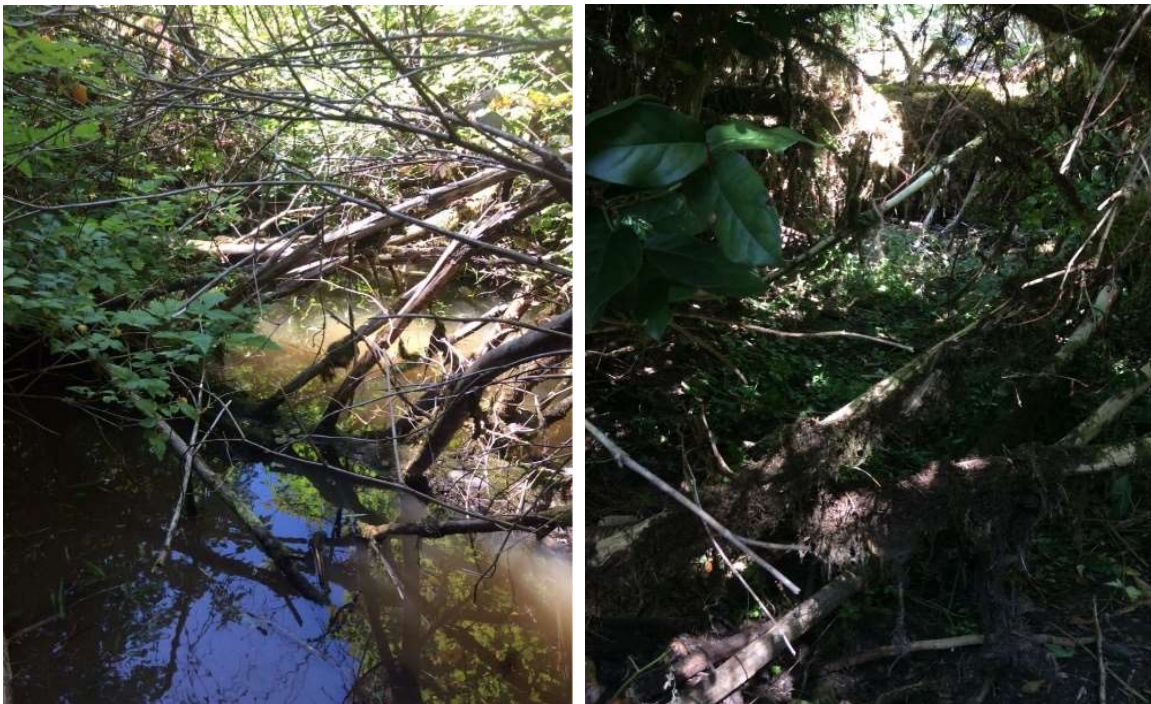
**Figure 10: Examples of woody debris in the channel downstream of the culvert**

The channel is less sinuous and straighter downstream of the culvert. Vegetation is dominated by abundant shrubs and trees on the stream banks and on the floodplain. There is extensive LWM and smaller wood present within a more confined channel within the first 100 feet downstream of the culvert outlet, with many large logs forming jams that present significant blockage of in-channel flows (Figure 10). The channel substrate is predominantly fines and some hardpan, but there are more distinct patches of larger gravel present compared with upstream (Figure 11). The channel becomes less confined more than 100 feet downstream of the culvert outlet, with several larger channel spanning, fallen trees that the stream flows under (Figure 12). Patches of gravel are more evident here than upstream. Both the channel and banks are made of fine material.

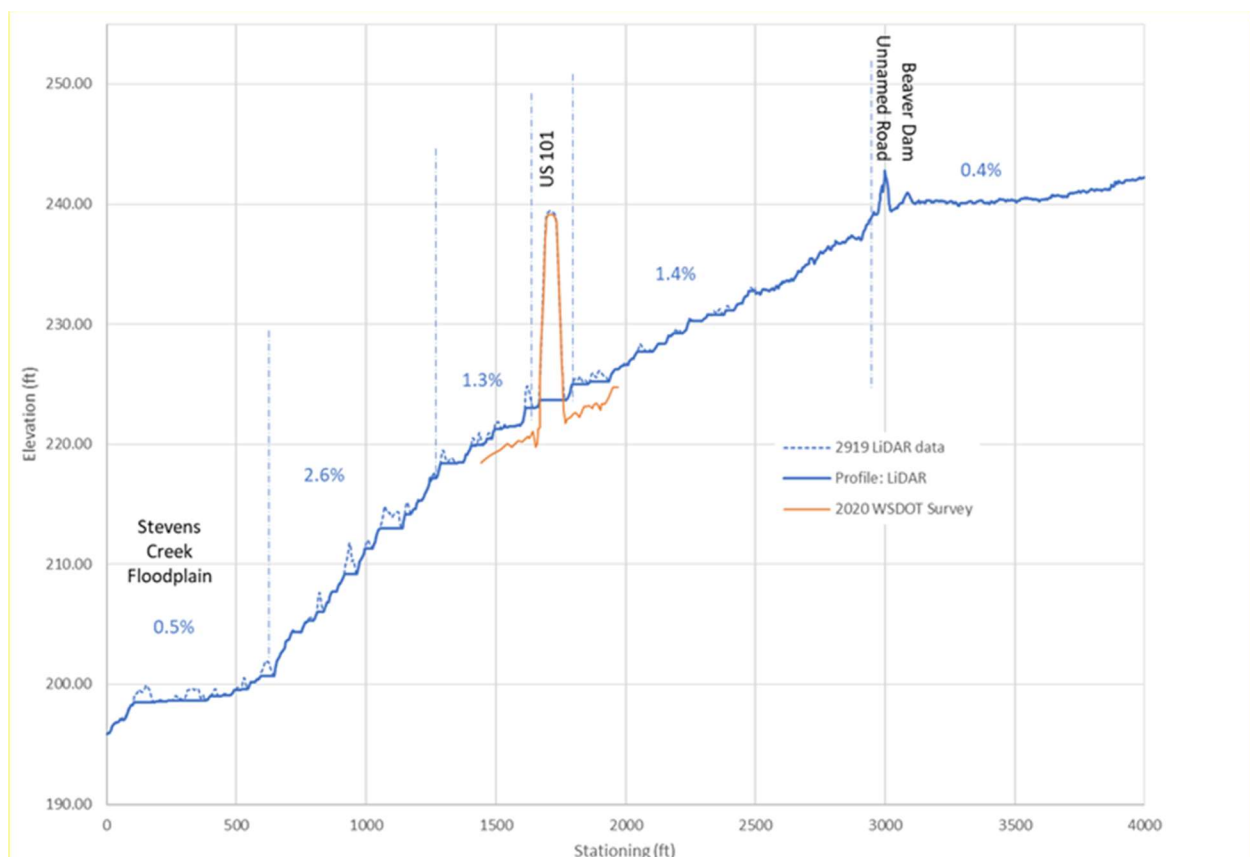
**Figure 16: Watershed-scale longitudinal profile, with gradients and 2020 WSDOT Survey Data**

Longitudinal profiles were developed from 2019 LiDAR data (Figure 16; USGS and Quantum Spatial 2019). 2020 survey data collected by WSDOT indicates that the channel elevations in the LiDAR data profile are higher than actual, but the bias appears to be consistent away from the road prism. The profiles were used to identify significant landmarks and breaks in the channel gradient that would influence spatial variation in sediment transport and deposition patterns that could be associated with a potential for future aggradation or degradation in the vicinity of the replacement structure. This knowledge is primarily important for designing the streambed longitudinal profile within the area of project effects, and the freeboard elevation and foundation depth of the replacement structure. The LiDAR profile presented in Figure 16 extends approximately 4,000 feet upstream and 2,000 feet downstream from the project culvert. The overall convexity of the channel profile and position of slope breaks are related to control that underlying geology exerts on the stream. On the glacial outwash plateau, the slope is low (around 0.5 percent), and includes a ridge that may be a defunct beaver dam. The slope increases at the edge of this plateau at a distance of about 1,300 feet upstream of the culvert. The gradient remains consistent and averages 1.4 percent on both sides of US 101.

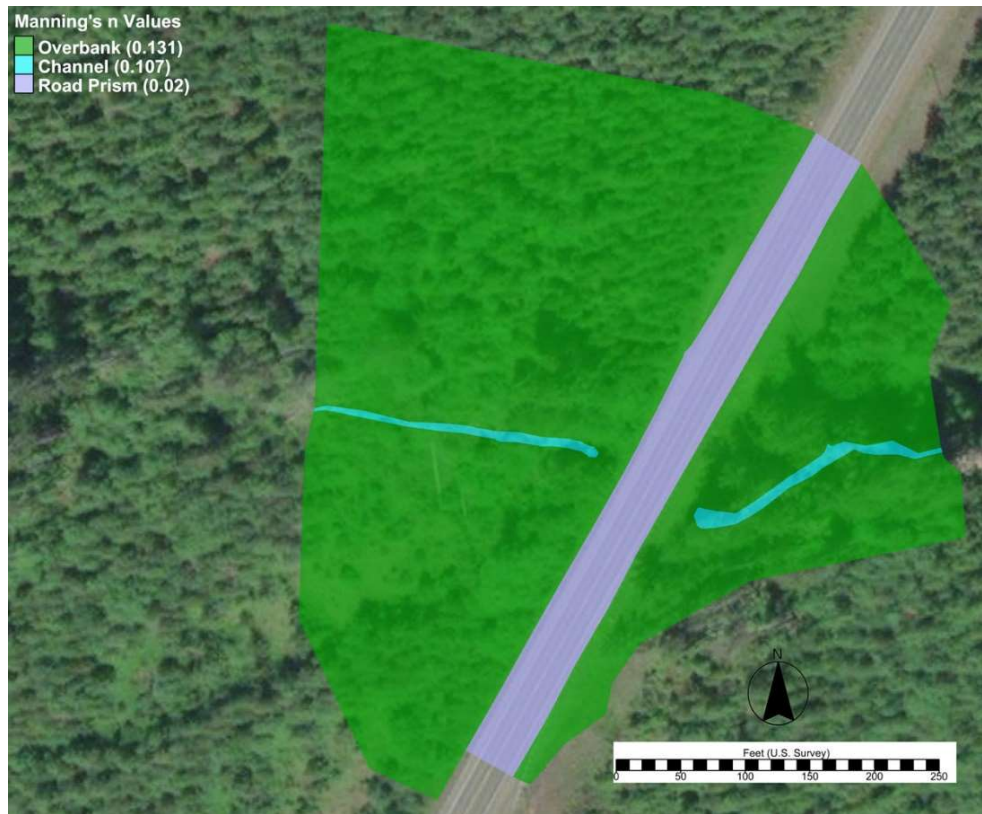
Figure 21: Spatial distributions of roughness values in existing-conditions SRH-2D model

Land cover type	Manning's $n$
Overbank	0.131
Channel	0.107
Road	0.020
Within Proposed Structure	0.041

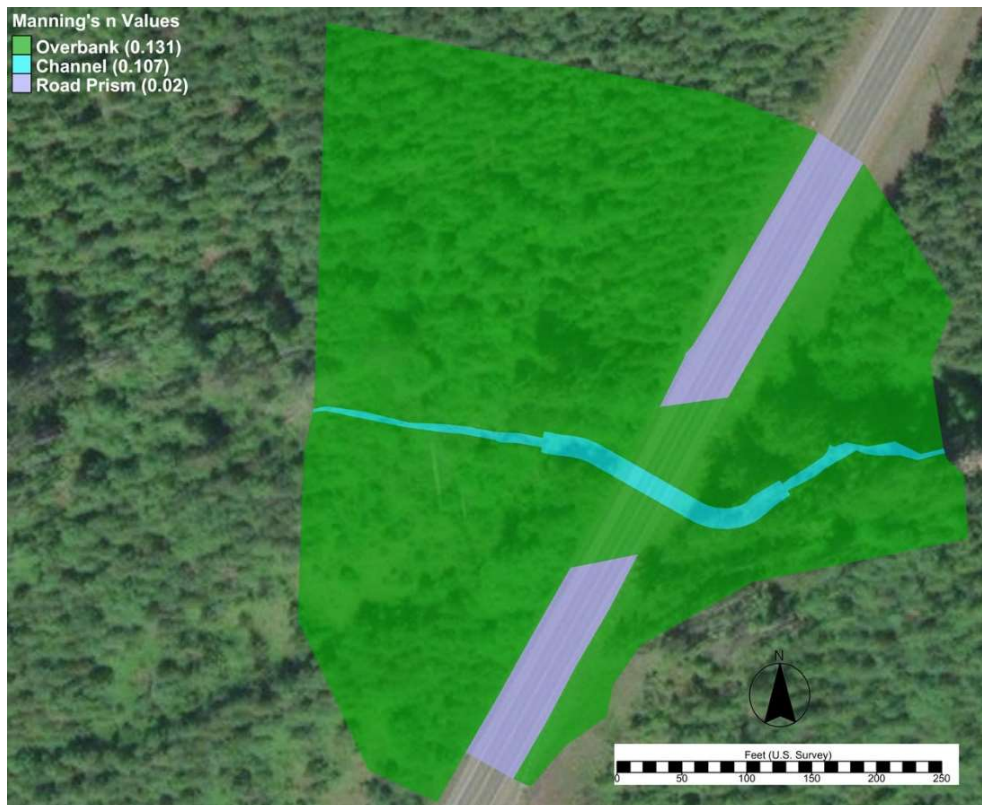
Figure 22: Spatial distributions of roughness values in natural-conditions SRH-2D model

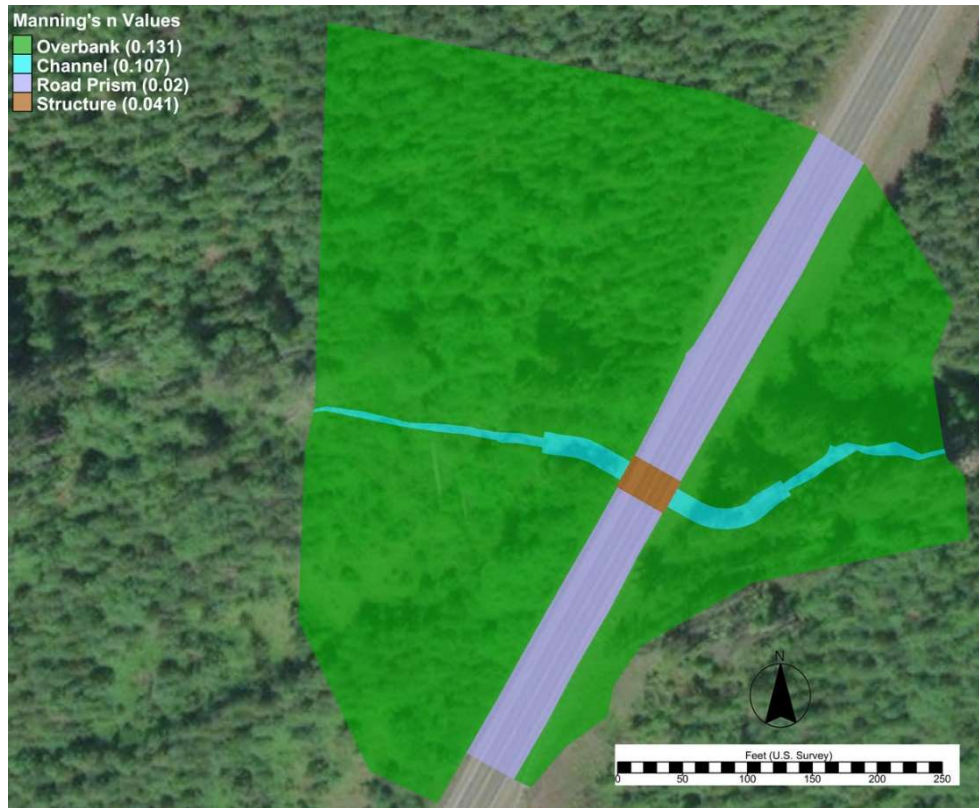
Figure 23: Spatial distributions of roughness values in proposed-conditions SRH-2D model

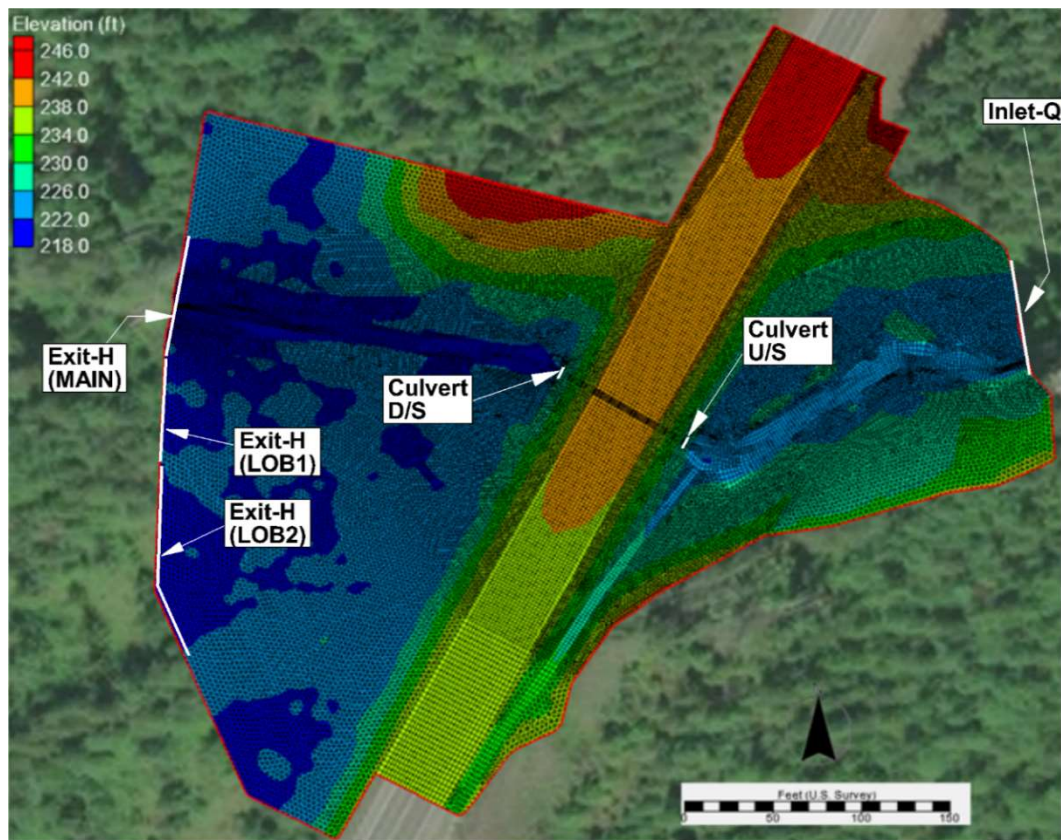
**Figure 24: Locations of boundary conditions for the existing-conditions model**

A constant flow rate was specified at the upstream boundary. Table 8 shows the simulated flow rate scenarios. Figure 24 shows the locations of external and internal boundaries in the existing-conditions model.

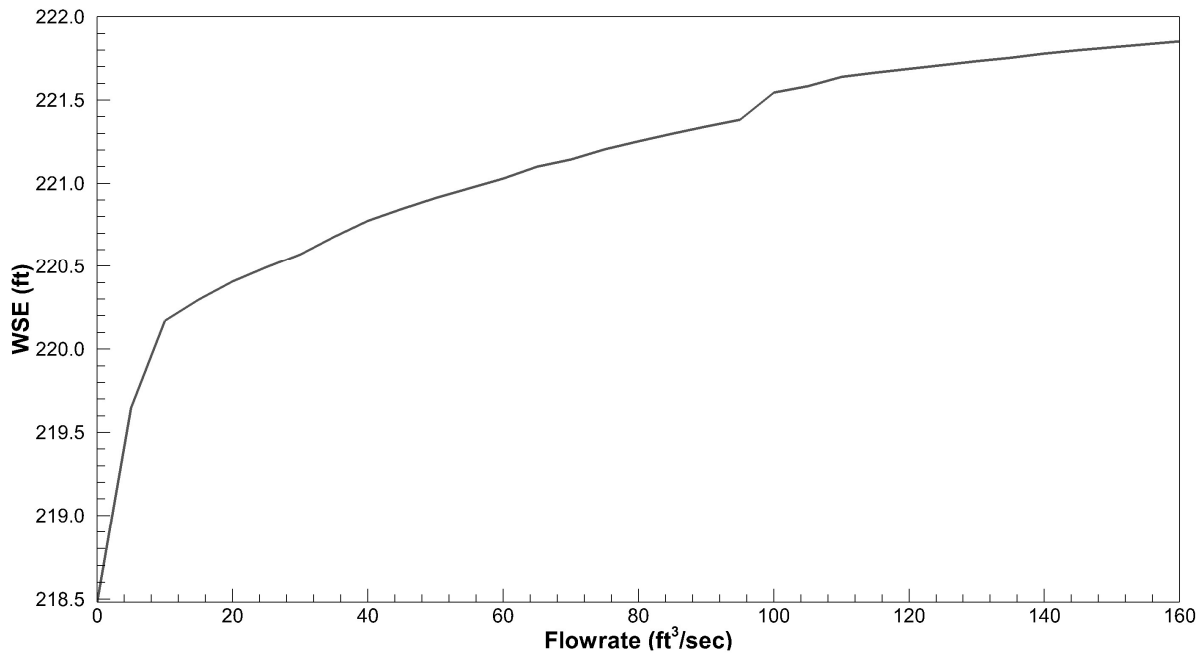
Figure 25: Normal depth rating curve for downstream boundary (main channel)

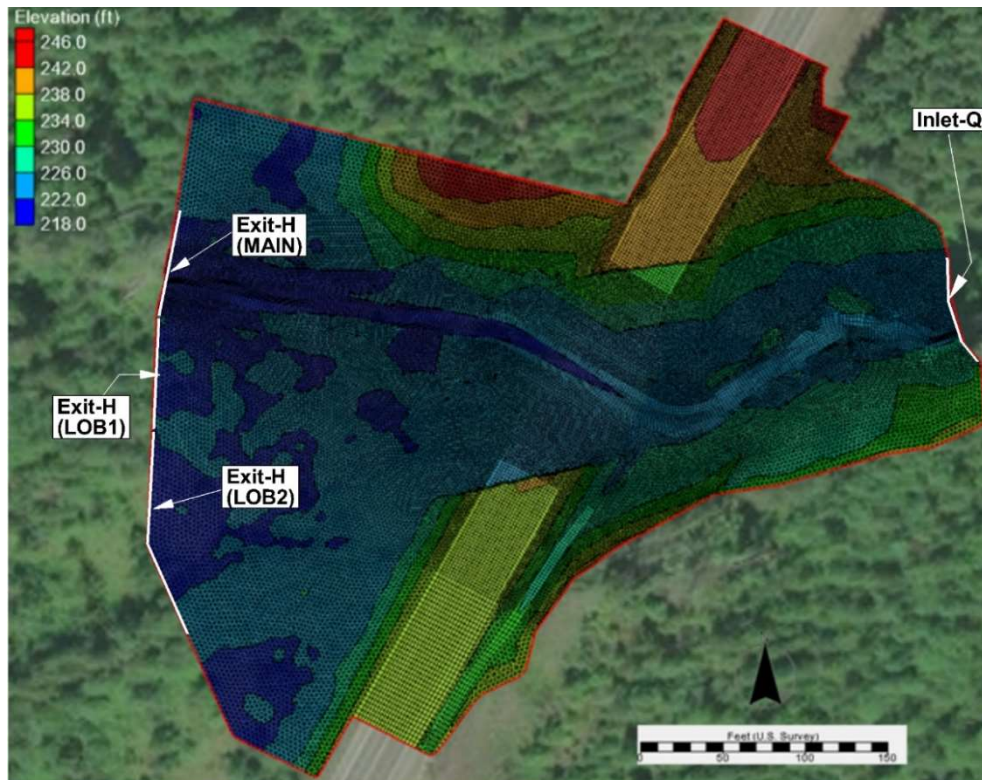
Figure 27: Location of boundary conditions for the natural-conditions model

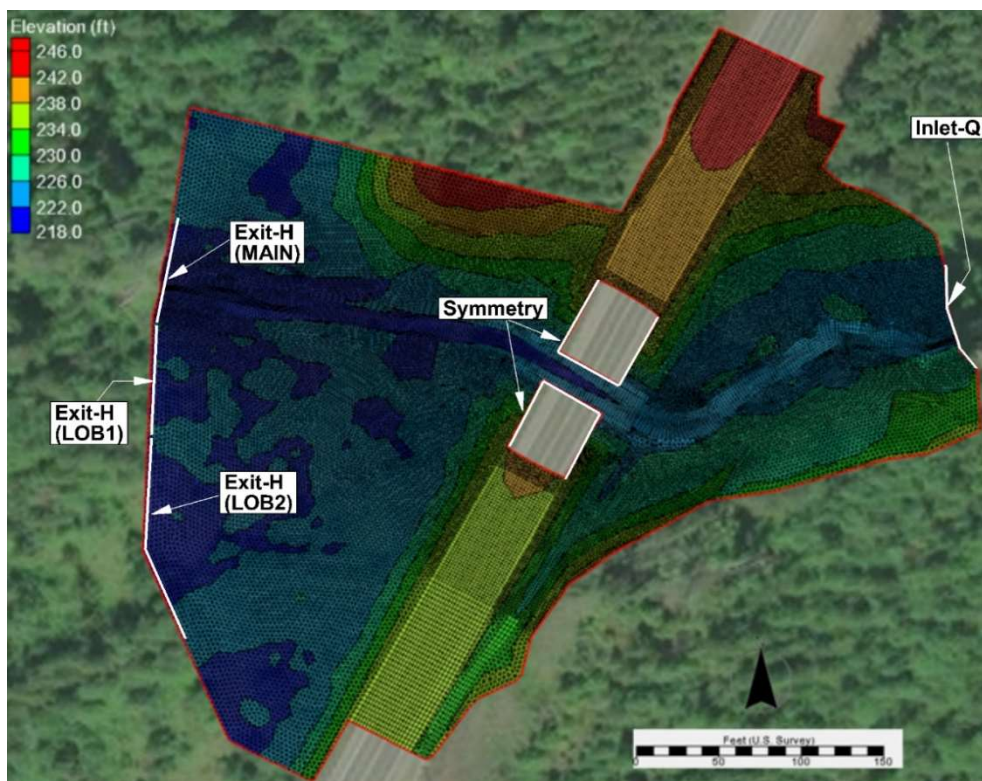
Figure 28: Location of boundary conditions for the proposed-conditions model

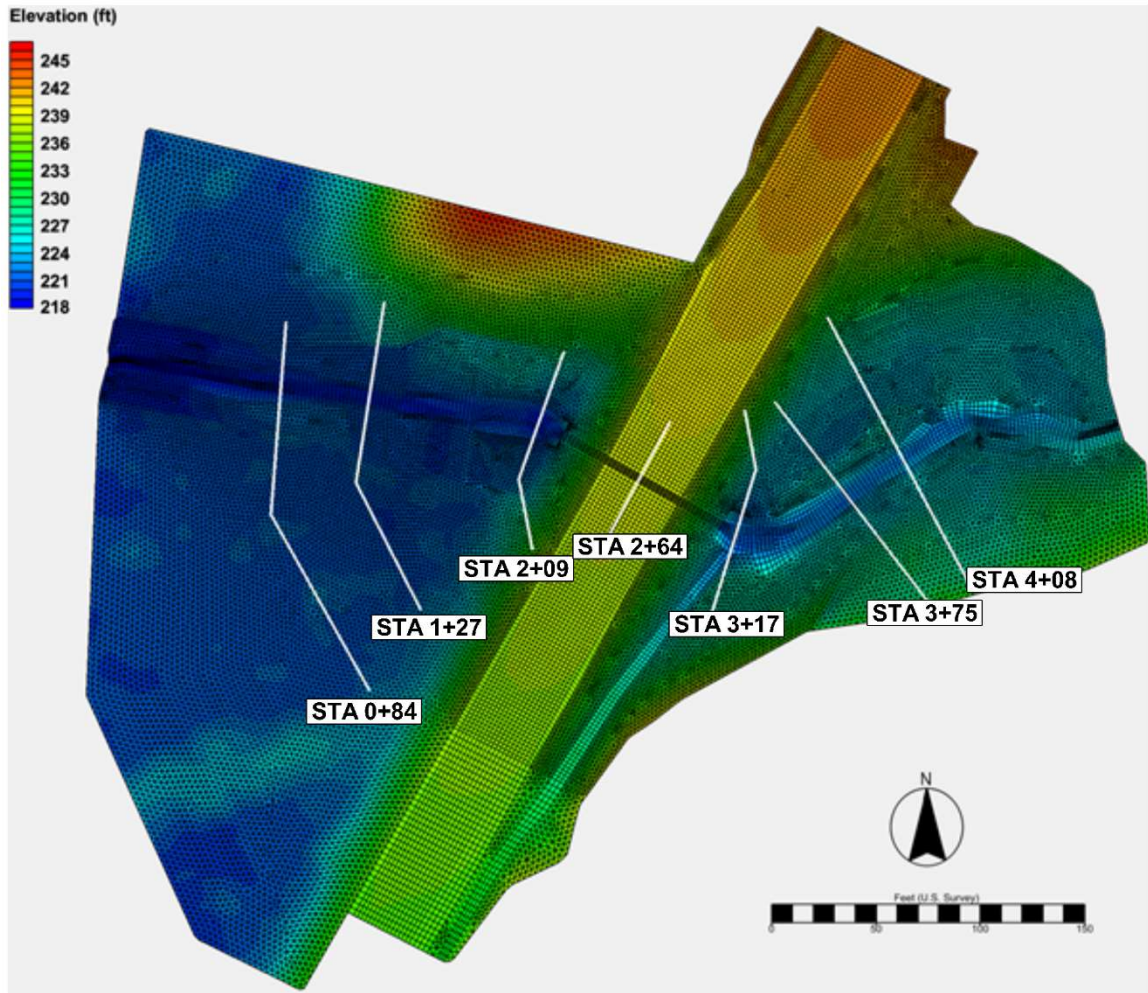
Figure 29: Locations of existing-conditions cross sections used for results reporting

Hydraulic results were summarized and compared at specific locations for the existing-conditions simulations. Seven cross sections (Figure 29) were selected to represent the model geometry on site: one at the roadway centerline, two in the selected reference reach upstream of the culvert, one immediately upstream of the culvert inlet, one immediately downstream of the culvert outlet, and two farther downstream. The cross sections just upstream and downstream of the culvert inlet and outlet show how the results change after installing the proposed structure. The reported hydraulic variables include maximum cross-sectional depth, cross-section averaged WSEL, velocity, and shear stress. Appendix C contains the detailed hydraulic results. In addition to the cross sections, results for existing, natural, and proposed conditions were summarized along the same longitudinal profile and stationing (Figure 30).

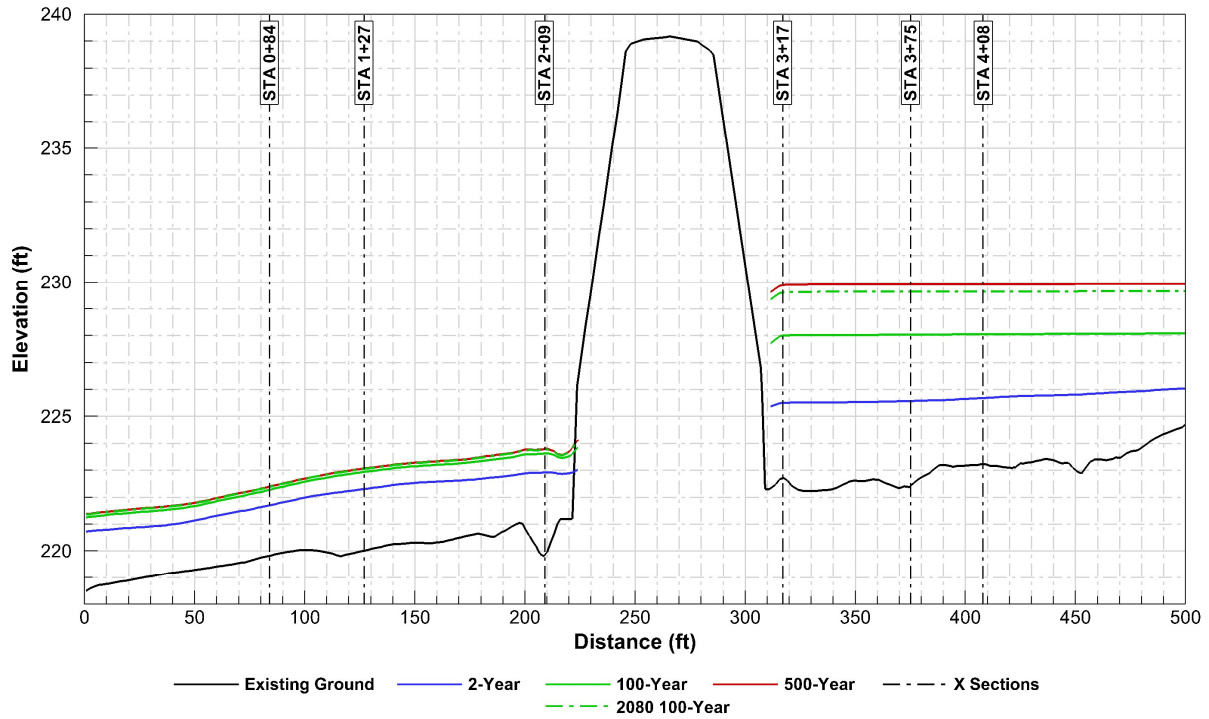
Figure 31: Existing-conditions water surface profiles

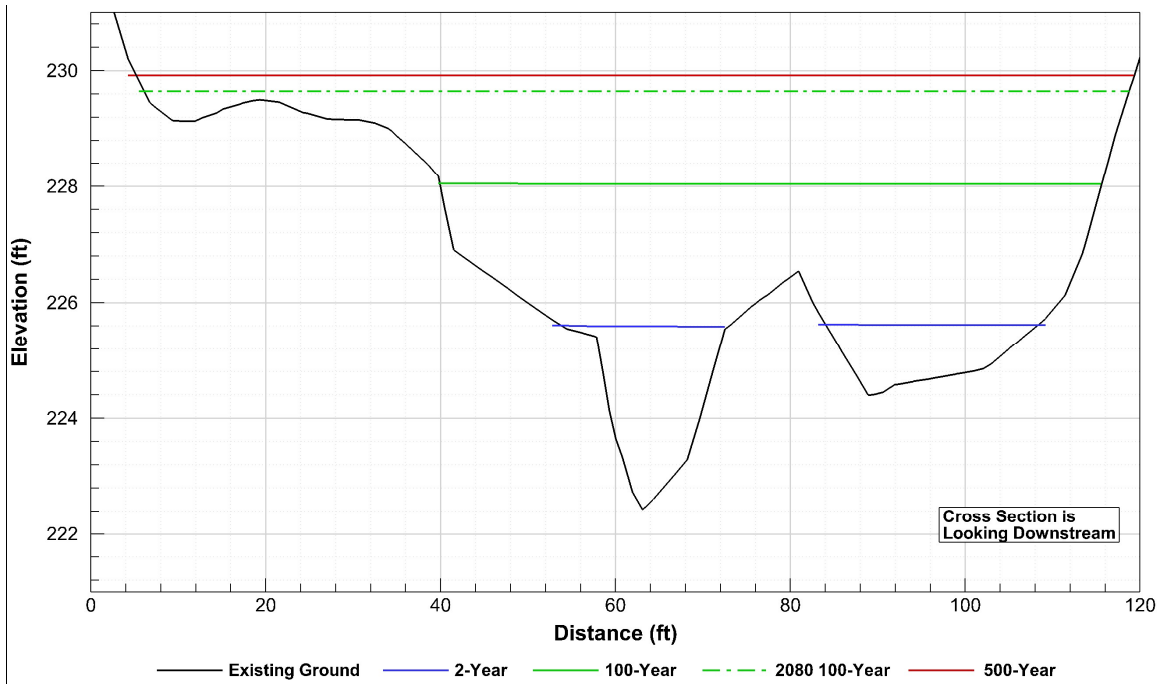
Figure 32: Typical upstream existing channel cross section (STA 3+75)

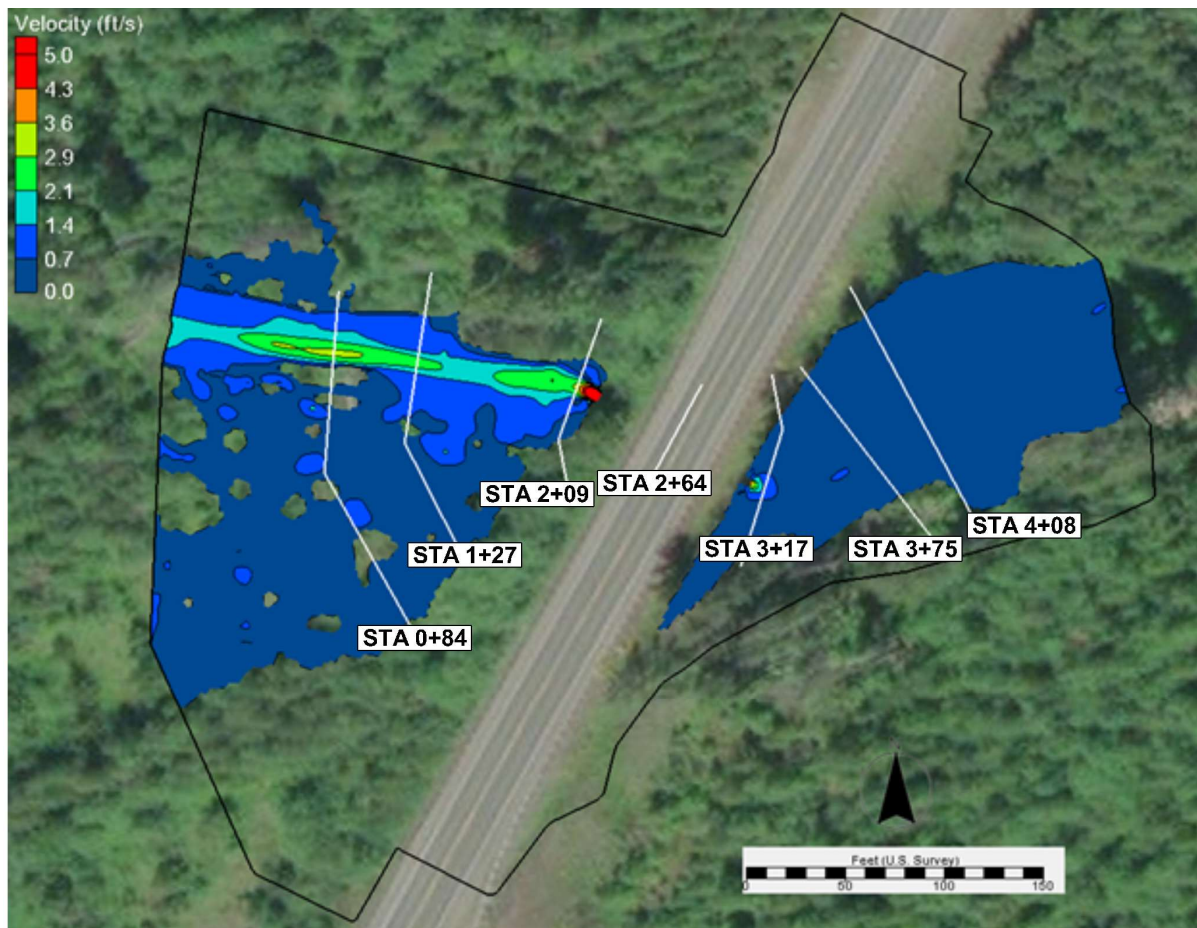
Figure 33: Existing-conditions 100-year velocity map with cross-section locations.

Table 9 summarizes the hydraulic results at seven cross sections for the project stream to Stevens Creek. Under existing conditions, the culvert is inlet controlled and causes backwater upstream of the inlet during all flow events simulated under U.S. 101 (Figure 31). Pressure flow in the existing culvert occurs for the 100-year flow event. The existing roadway was not overtopped within the range of flow events modeled for the proposed stream. A typical upstream section with WSELs is depicted in Figure 32. The maximum predicted velocities occur at the U.S. 101 culvert outlet (Figure 33).

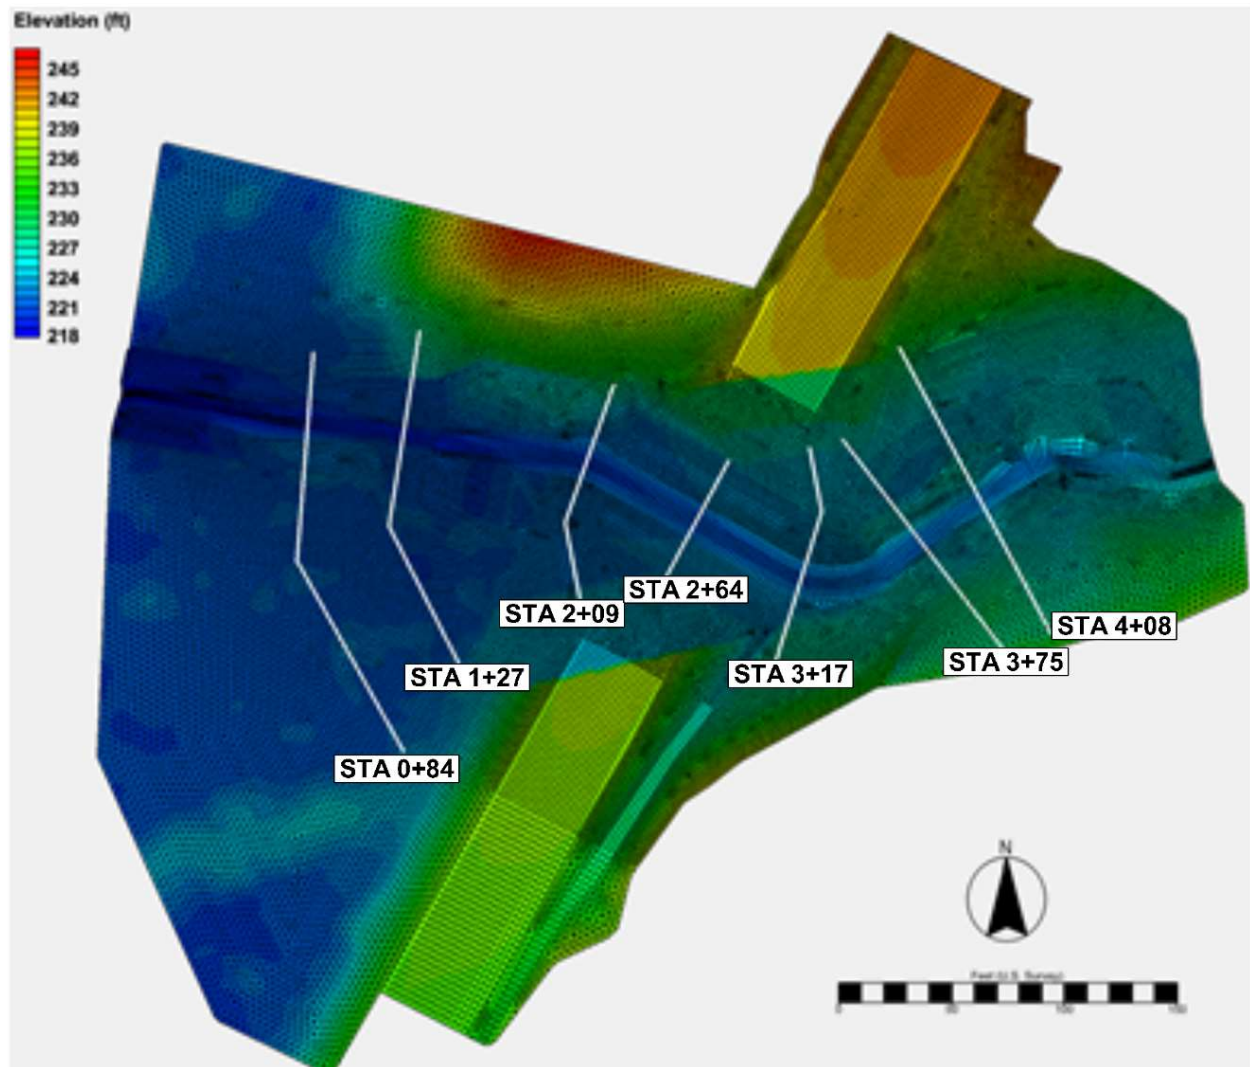
Figure 34: Locations of natural-conditions cross sections used for results reporting

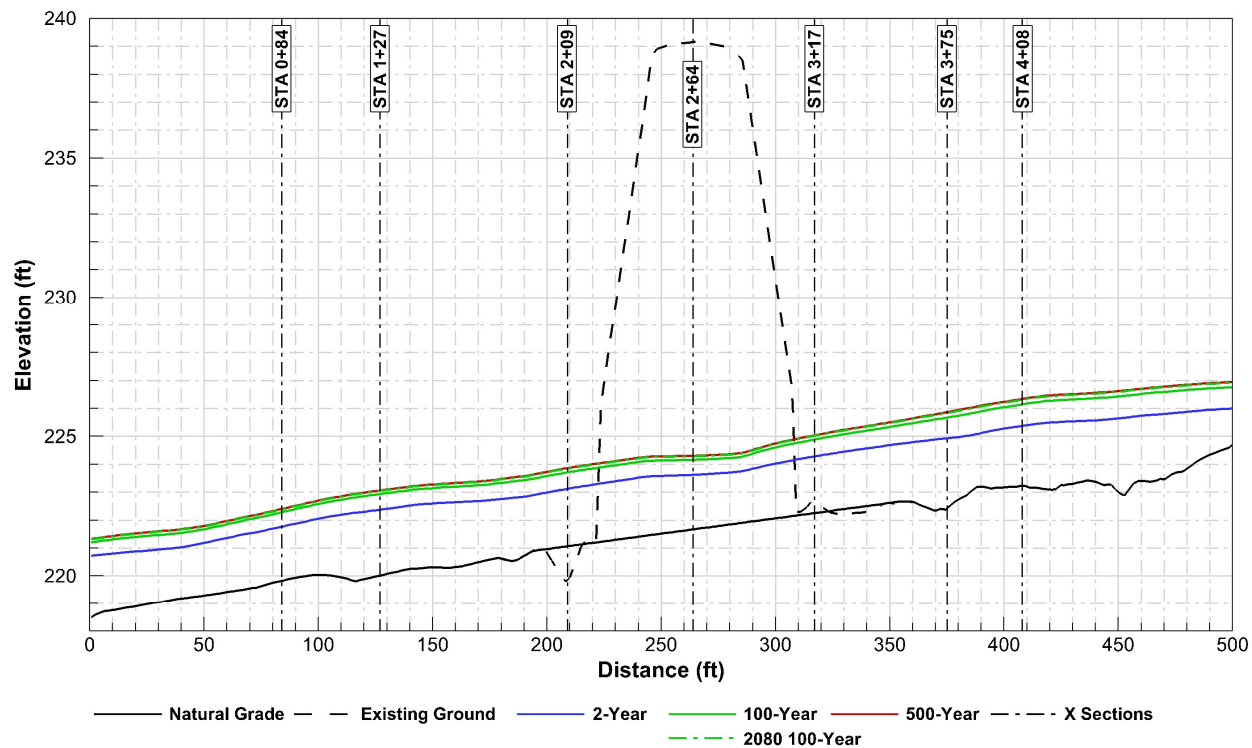
Figure 35: Natural-conditions water surface profiles

The WSELs for the range of flows simulated are depicted along the longitudinal profile in Figure 35. Under natural conditions, the crossing does not backwater or overtop U.S. 101. However, flow is still spread across the floodplain upstream and downstream because of low banks and flat floodplains. Typical cross sections for downstream and upstream are found in Figures 36 and 37, respectively. Both cross sections show an unconfined channel spreading flow into the floodplains at low flows. All cross sections are provided in Appendix C. Figure 38 depicts the predicted velocity map for the 100-year flood

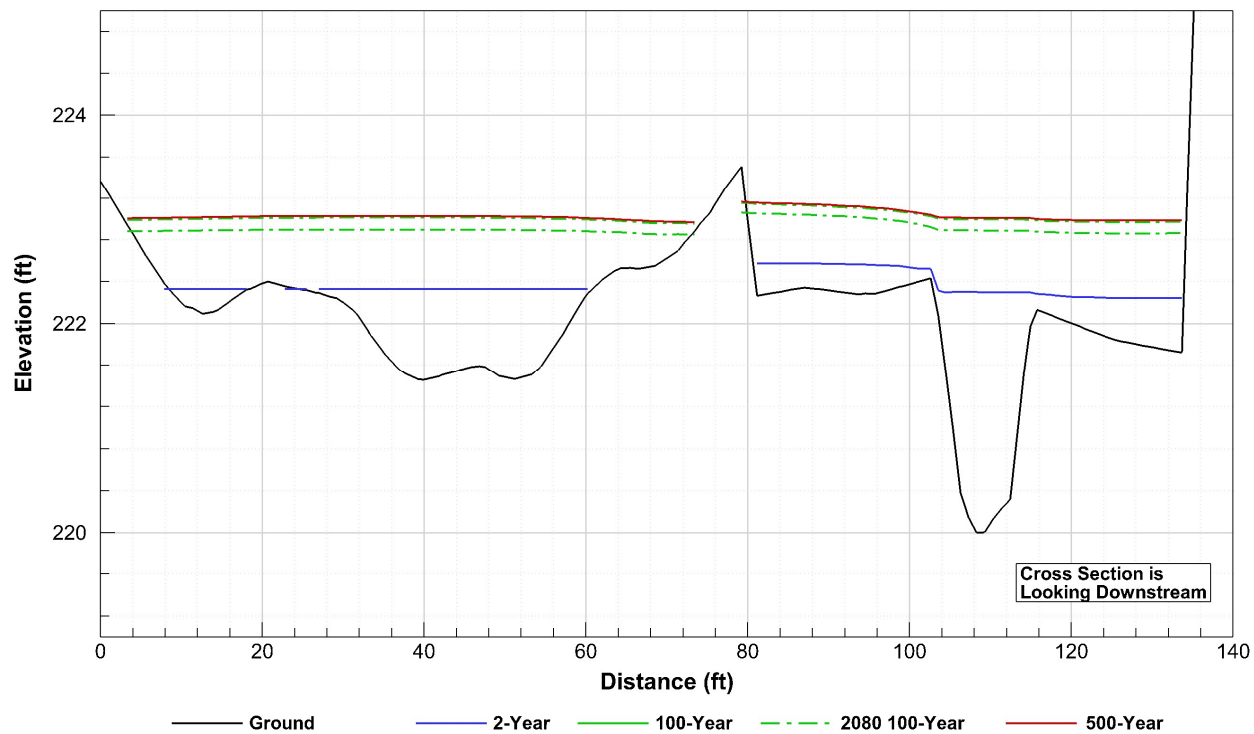
Figure 36: Typical downstream natural-conditions channel cross section (STA 1+27)

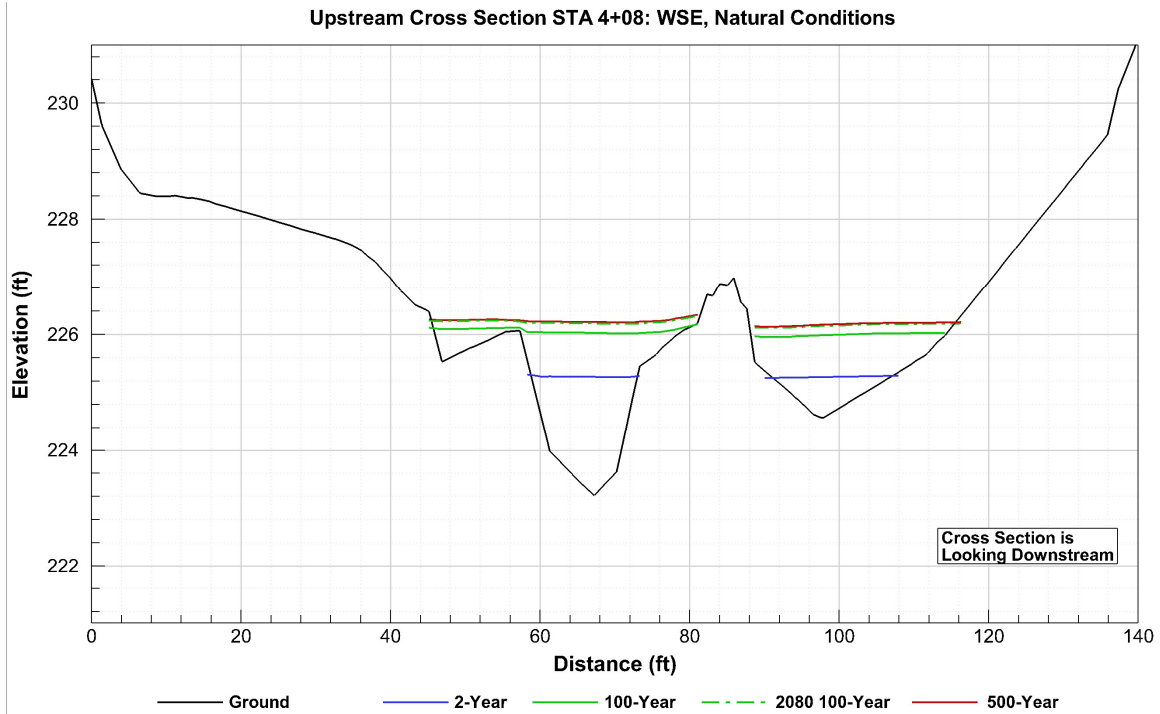
**Figure 37: Typical upstream natural-conditions channel cross section (STA 4+08)**

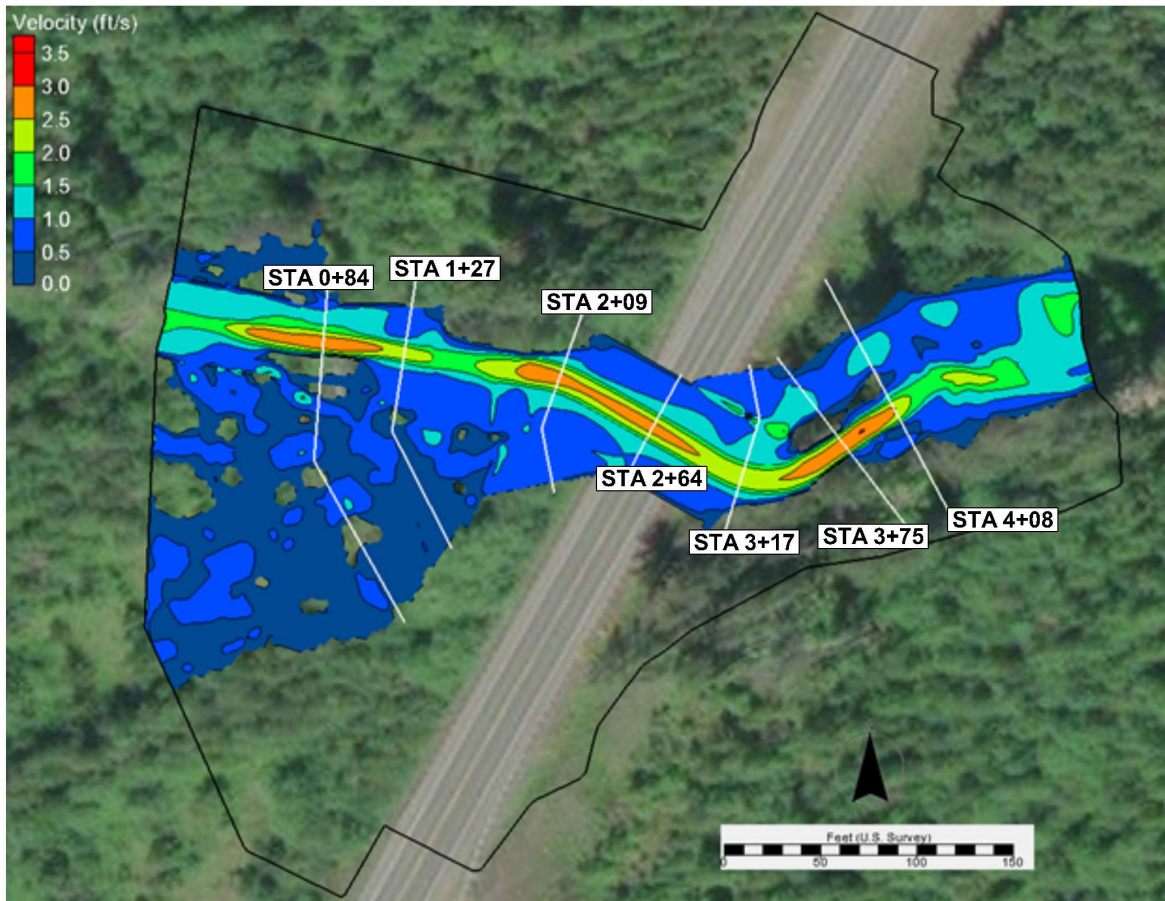
**Figure 38: Natural-conditions 100-year velocity map with cross-section locations**

peak. Predicted upstream depths and velocities are similar to values downstream. The similarities in velocity reflect similar cross-section shapes and slopes, and flow spreading evenly across floodplains upstream, downstream, and through the removed road embankment.

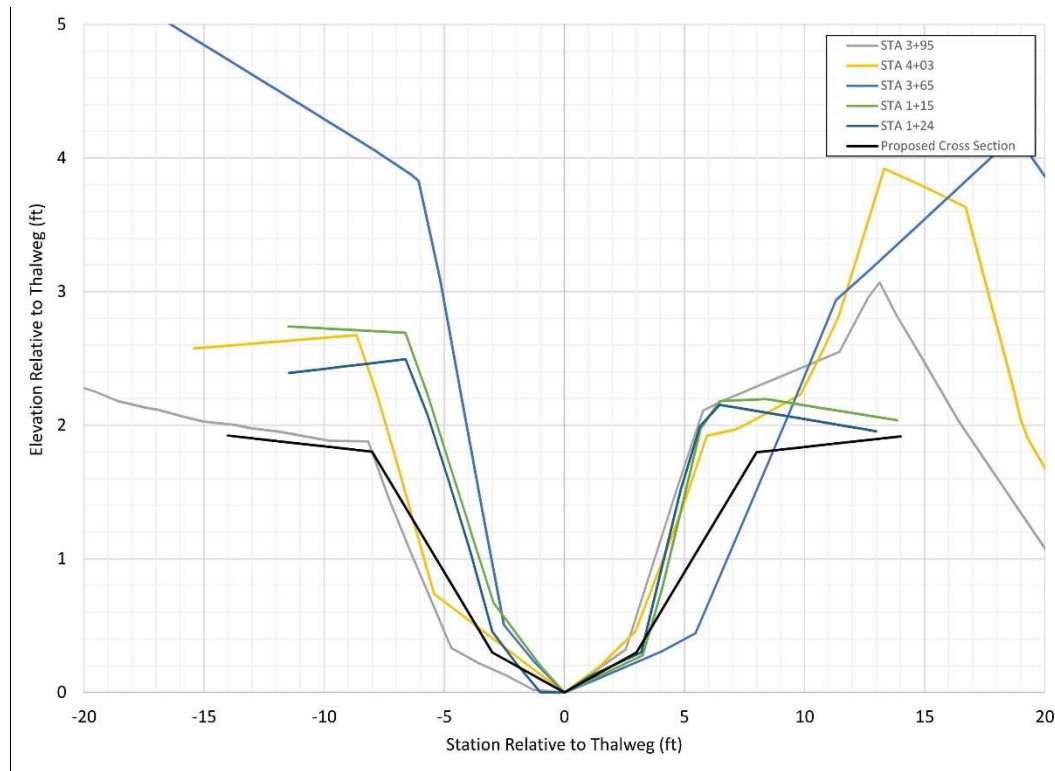
**Figure 41: Proposed cross section at the structure superimposed with cross sections used to determine BFW**
